## Technical Report TR-2040-OCN

### FDS-D WET-END SURVIVABILITY POST TEST ANALYSIS

Sponsored by  
Space and Naval Warfare Systems Command  
Arlington, VA 22245-5200

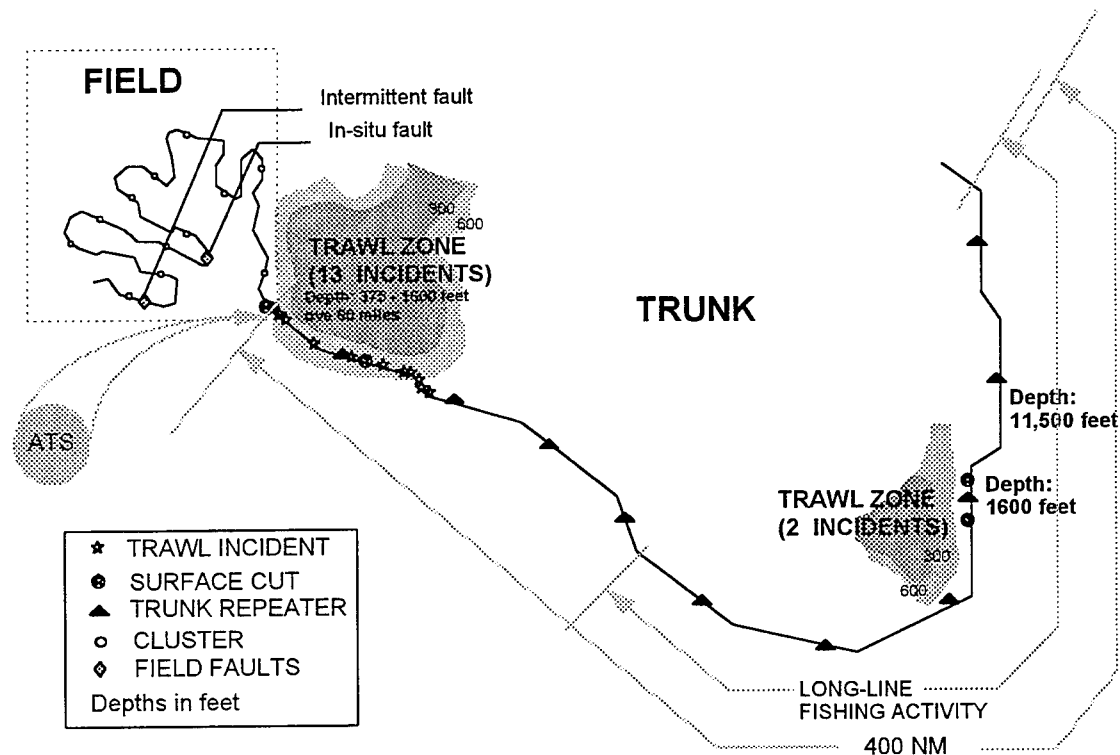
**FIGURE 1. FDS-D UWS IN-SITU FAULTS**

Figure 1 identifies the locations of the in-situ faults.

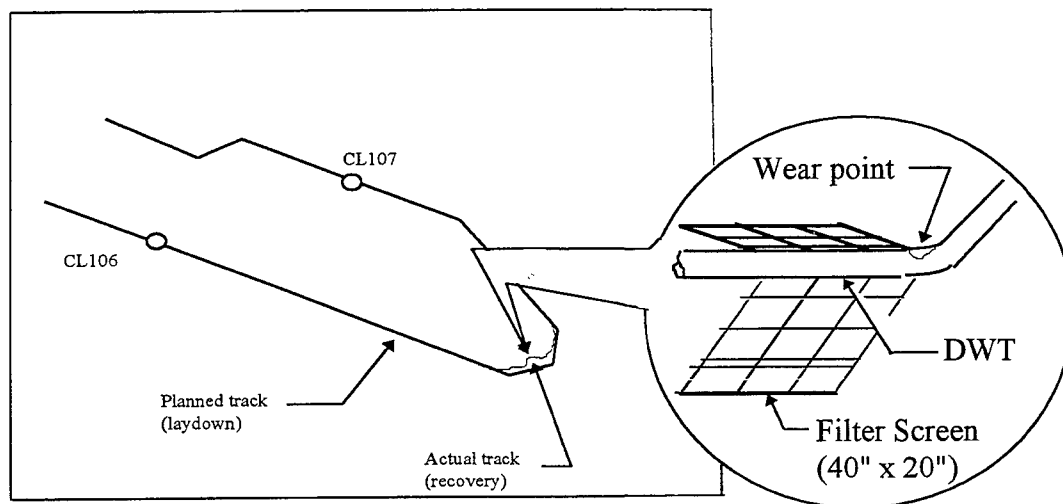
**FIGURE 2. FAULT BETWEEN CL106 AND CL107**

**2.2.2 Cut and/or Abrasion Compounded with Corrosion and Cold Flow.** One failure occurred in the field that was not trawling related -- the cable became entangled with a steel wire filter screen on the seafloor between CL106 and CL107. The failure appears to have been caused by an initial cut in the cable jacket from the filter screen, compounded with corrosion and cold flow. The failure resulted after a prolonged period of operation (81 days). The entanglement may have been initiated during installation. The evidence points to the cable being pulled through a turn during installation while the deployment ship was making a sharp course change. High surface current velocities of up to two knots were recorded near the fault position, which may be a contributing factor. No damage was observed on either side of the fault point, and no evidence supports that the cable was dragged at this point after deployment. Although site specific factors may be involved, **the scenario suggests that this failure mechanism could be a problem in future FDS deployments.**

No evidence was found to link this fault to trawling. The failure occurred in the middle of a 160-degree turn in the laydown track. The filter screen was bent or doubled over at a hard angle around the cable and a wear point developed where it made contact with the cable. The configuration of the filter screen on the cable and the cable location during recovery led to the hypothesis that the cable was inadvertently pulled through the turn during deployment. Hence, this fault is theorized to have been caused by a combination of the following:

- Excessive tension in the cable.
- In situ hazard that resulted in a cut or abrasion to the jacket.
- Corrosion of the steel shield.
- Cold-flow of the dielectric and electrical failure of the cable.

Figure 2 illustrates this problem.

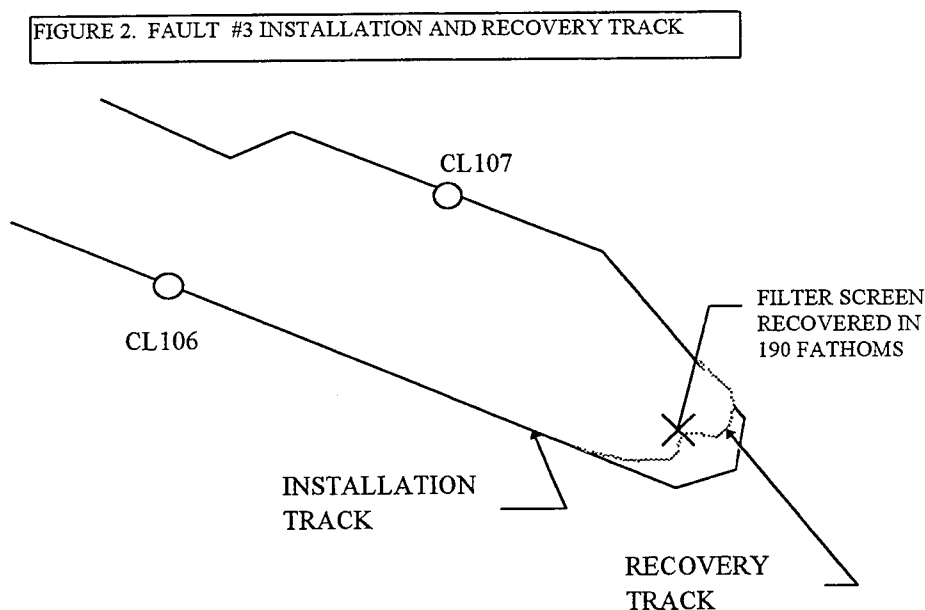
One unique failure occurred in the field that was not trawling related -- a steel wire filter screen became wrapped around the cable on the seafloor. The entanglement presumably began during deployment. The failure appears to have been caused by an initial cut against the filter screen, compounded with corrosion and cold flow. The failure resulted after prolonged period of operation (81 days). The evidence points to the cable being over-tensioned during installation while the deployment ship was making a sharp course change. No damage was observed on either side of the fault point, and no evidence supports that the cable was dragged at this point after deployment. Although site specific factors may be involved, the scenario suggests that this failure mechanism could be a problem in future FDS deployments.

The failure was located between CL106 and CL107. The cause of the failure was discovered during the recovery when a steel wire filter screen was brought to the surface wrapped around the cable. The filter screen looked like it came from an air vent on a shipwreck or from a dump site. The filter screen was wrapped at a hard angle around the cable, indicating the cable was under tension while in contact with the filter screen on the seafloor. The cable jacket and dielectric had cold-flowed around the filter screen wire where it made contact with the cable. The failure occurred in the middle of a 160-degree turn in the field laydown track, which supports the theory that the cable was over-tensioned and pulled through the turn until it hooked onto the filter screen. Figure A-2 provides a drawing of the laydown and recovery track.

During recovery, no damage was observed on either side of the fault point, and no evidence was found that the cable had been hit or dragged by trawl gear after the cable reached its in-situ location. The lack of evidence of external forces causing the damage, such as trawling, leads to the hypothesis that the cable fault was the result of an in-situ hazard condition combined with a cable design vulnerability. This scenario could also be further complicated by too little slack control at the deployment ship during installation. This cable fault is theorized to have been caused by a combination of cut and abrasion to the jacket, corrosion of the steel shield, cold-flow of the dielectric, and electrical failure. Although this would be the first known failure to have occurred this way, corrosion evidence gathered from autopsy samples support that a major vulnerability of FDS DWT may exist for this mechanism

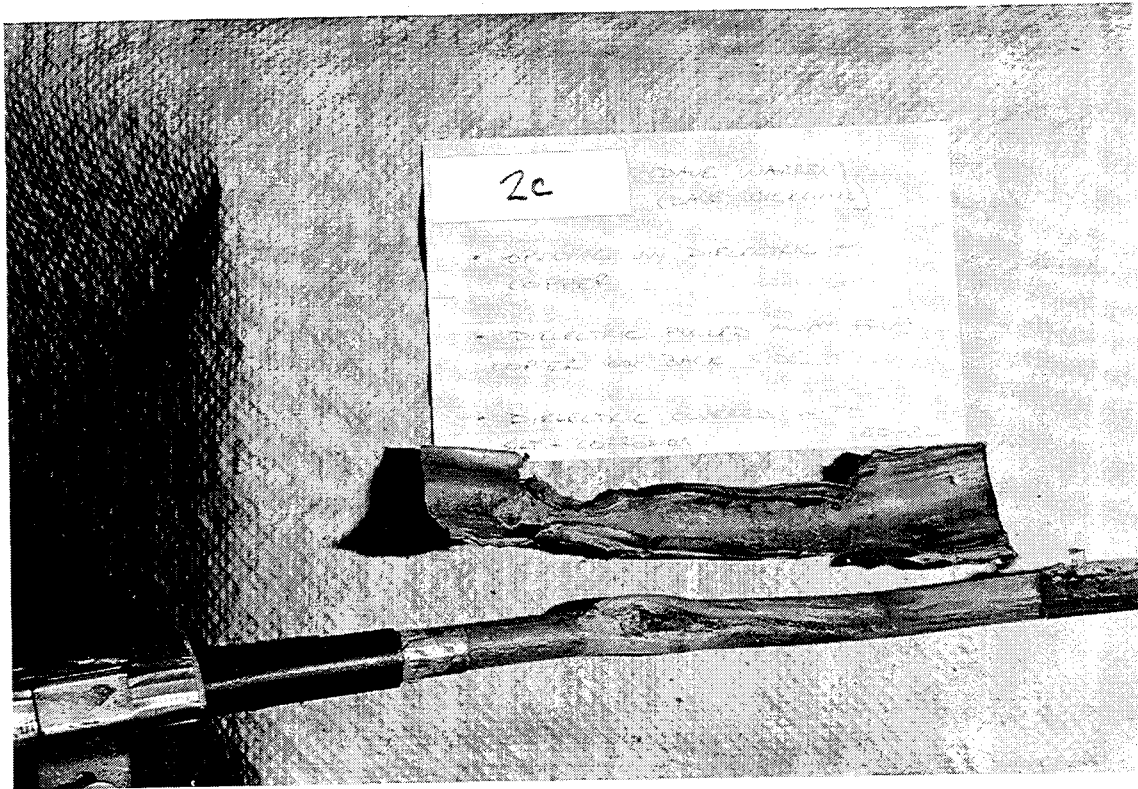
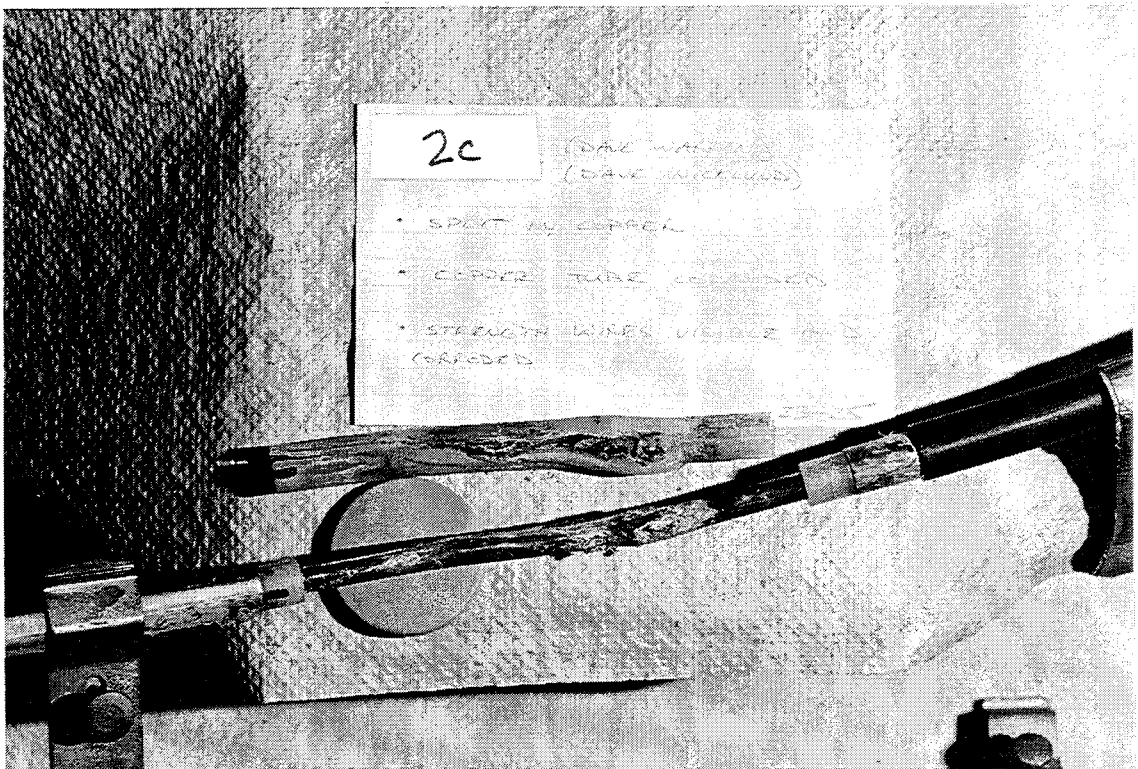
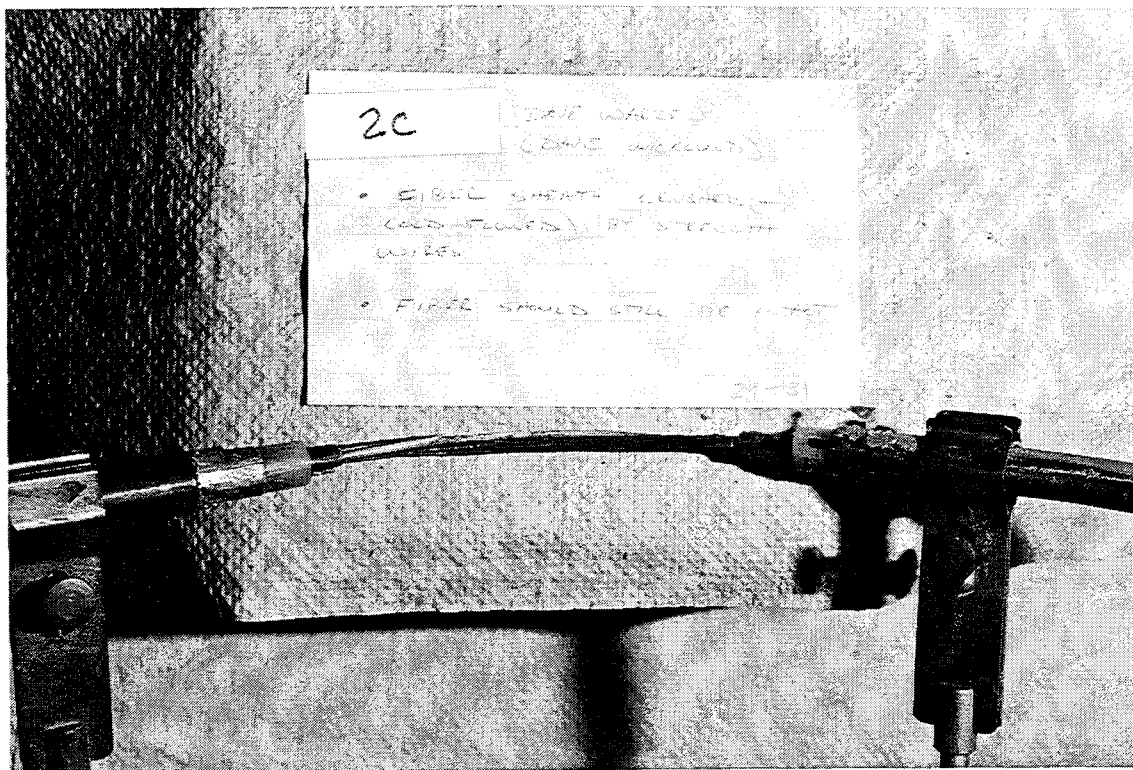
## 5.4 Fault Number 2c - FDS-D CABLE AUTOPSY WORKSHEET

Condition of Optical Fiber Sheath: The sheath is intact but has been crushed by the strength wires. The nylon jacket and buffer have cold-flowed when crushed by the inner layer of wires.

Condition of Fiber: By a visual inspection the fiber appears intact. Power meter tests were not possible.

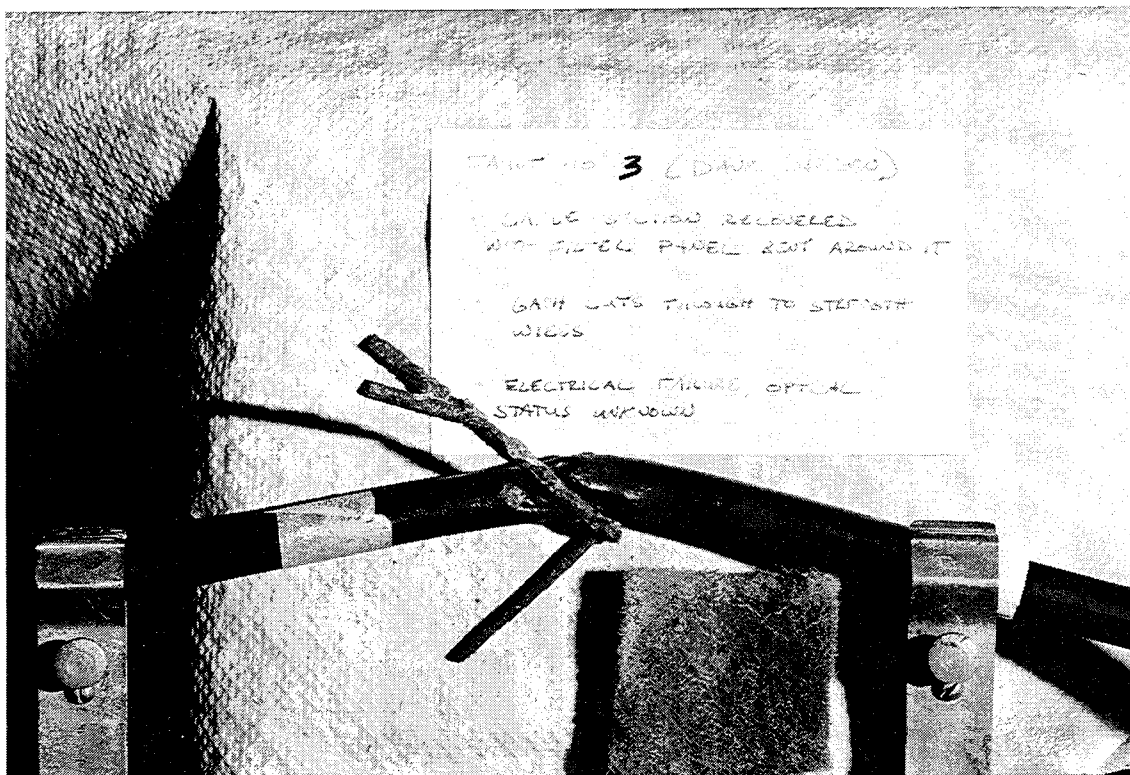
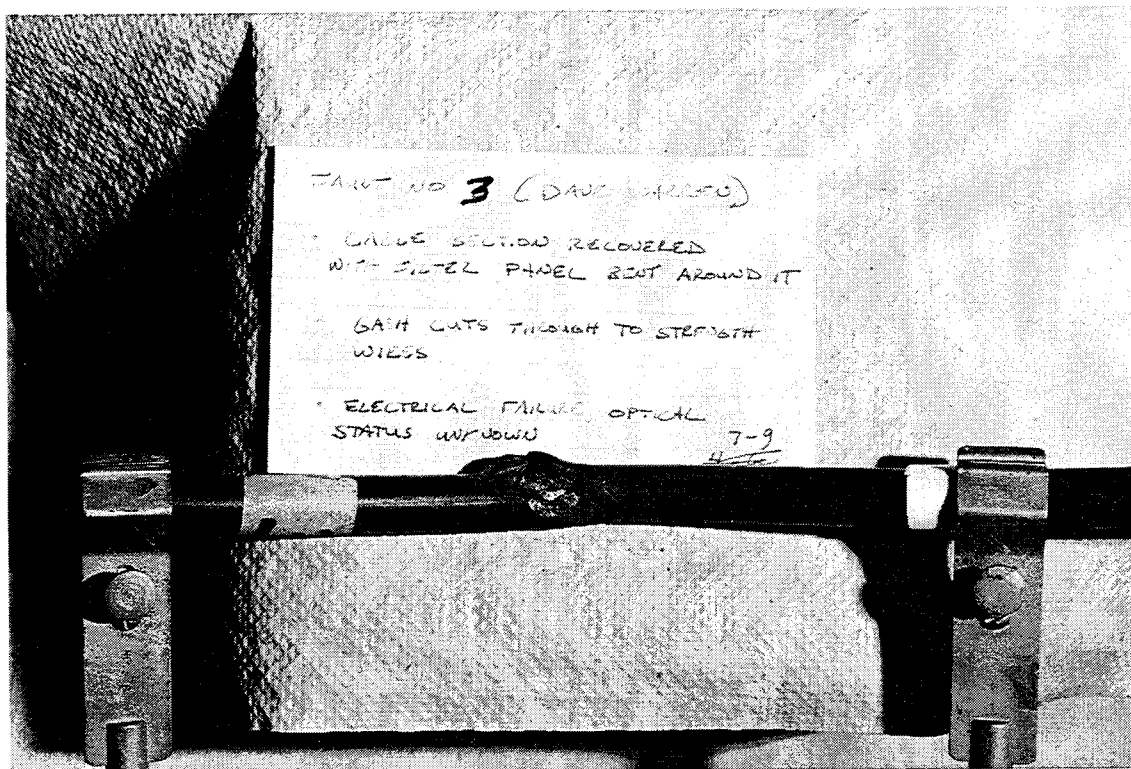
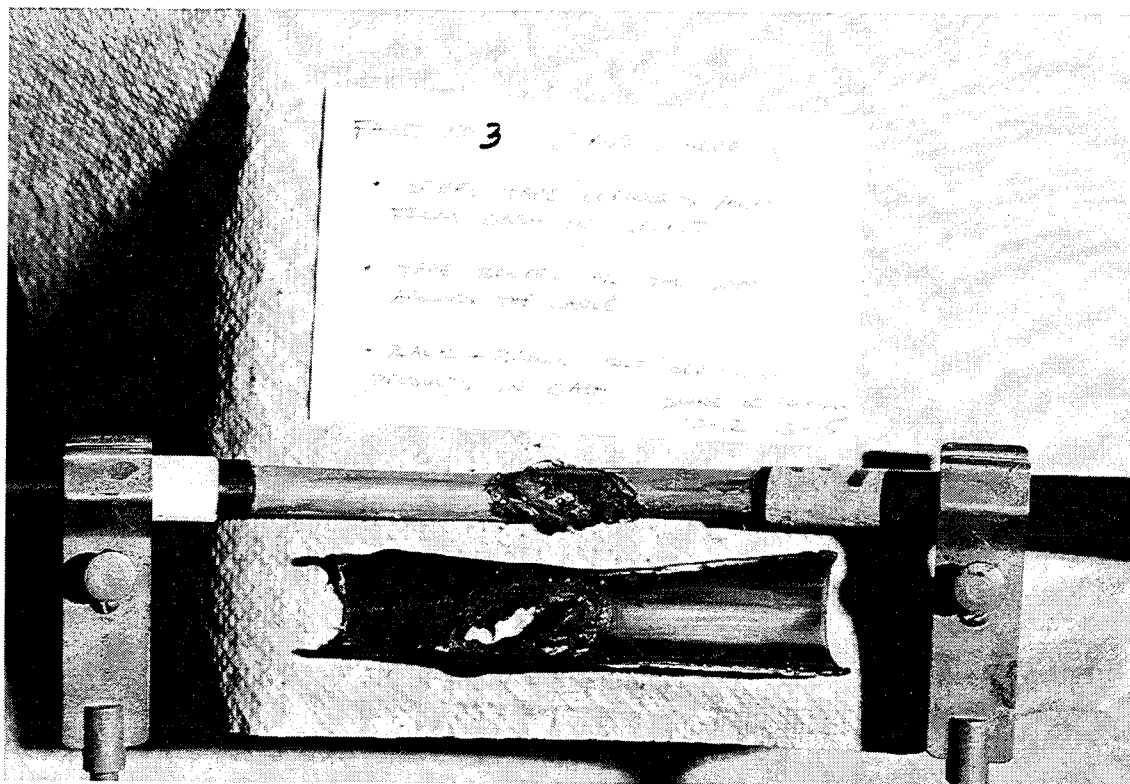
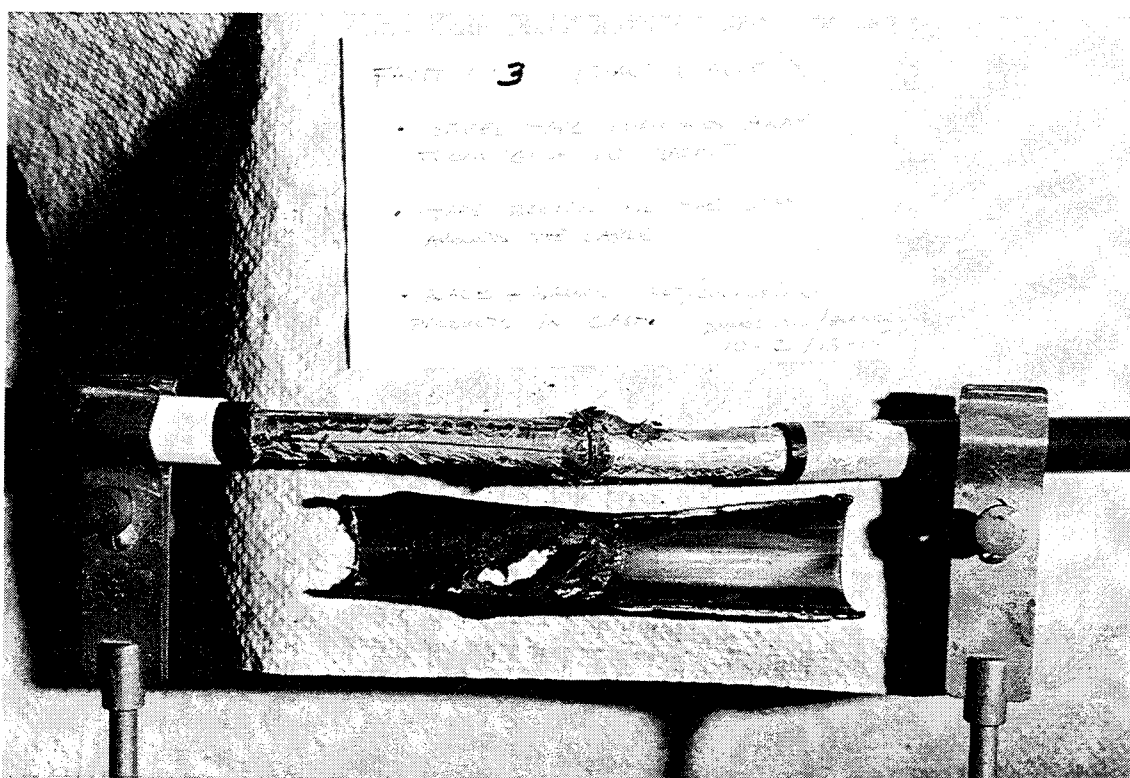
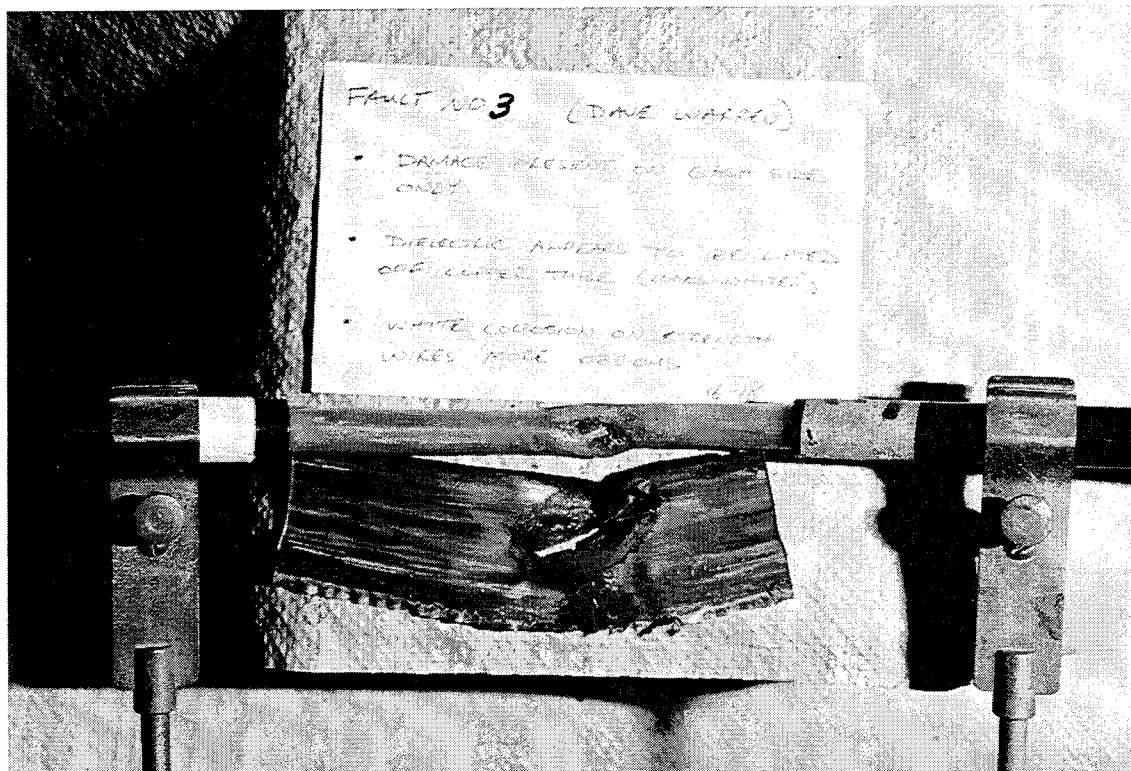
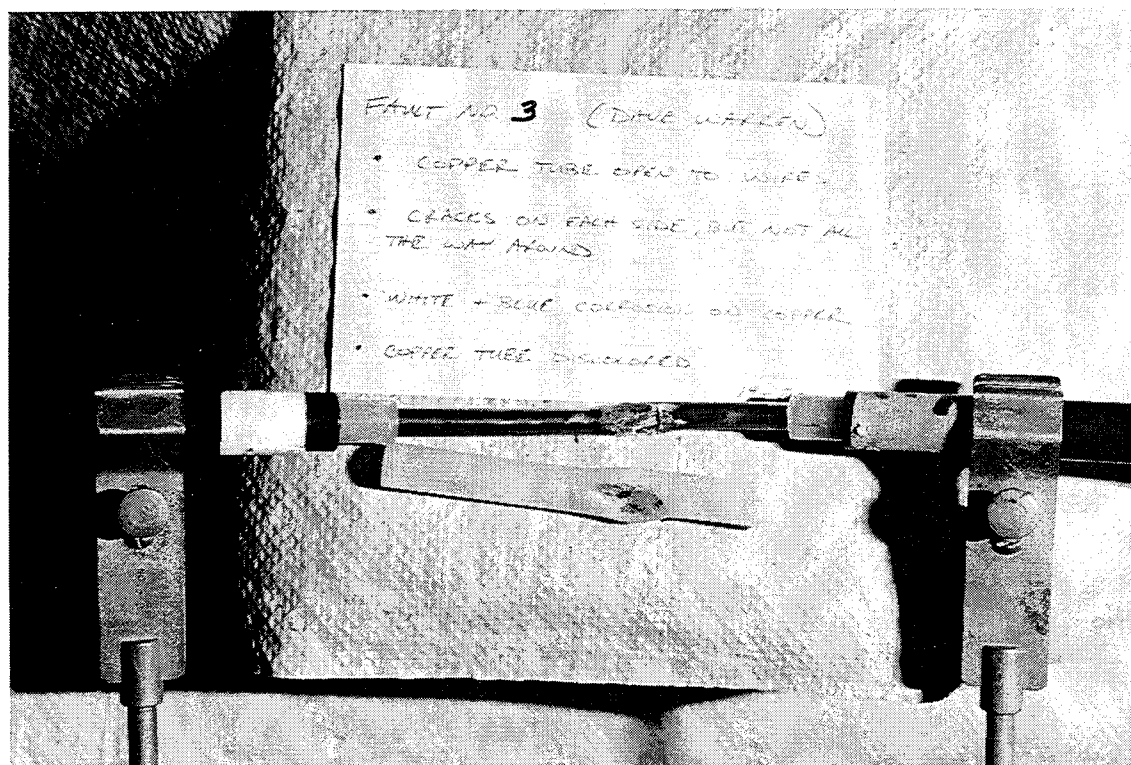
## 5.5 Fault Number 3 - FDS-D CABLE AUTOPSY WORKSHEET

Condition of Optical Fiber Sheath: The sheath has cold flowed into spaces between inner layer of strength wires. Sheath is discolored (yellow/mustard) corrosion from wires stuck on the sheath.

Condition of Fiber: Unknown. Attempted to check with a bare fiber adapter - unsuccessfully, but can't say that the fiber is bad. Fiber may be broken at the point where the pigtail emerges from the end of the sample.

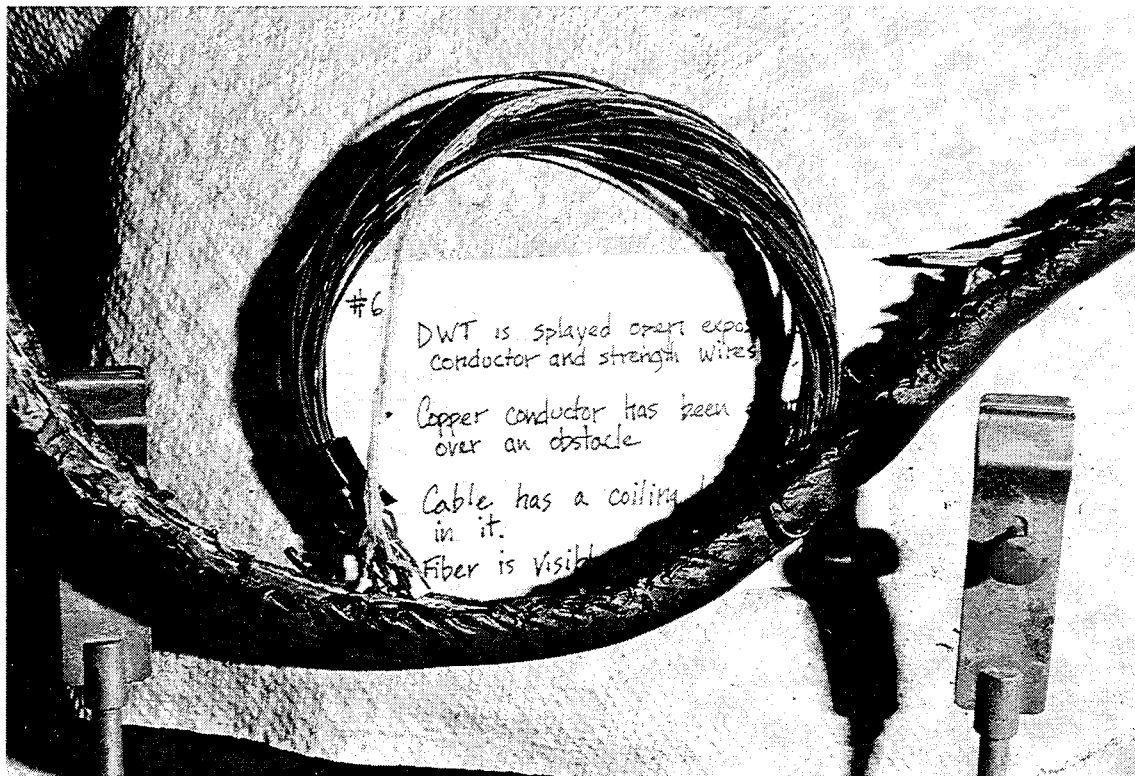
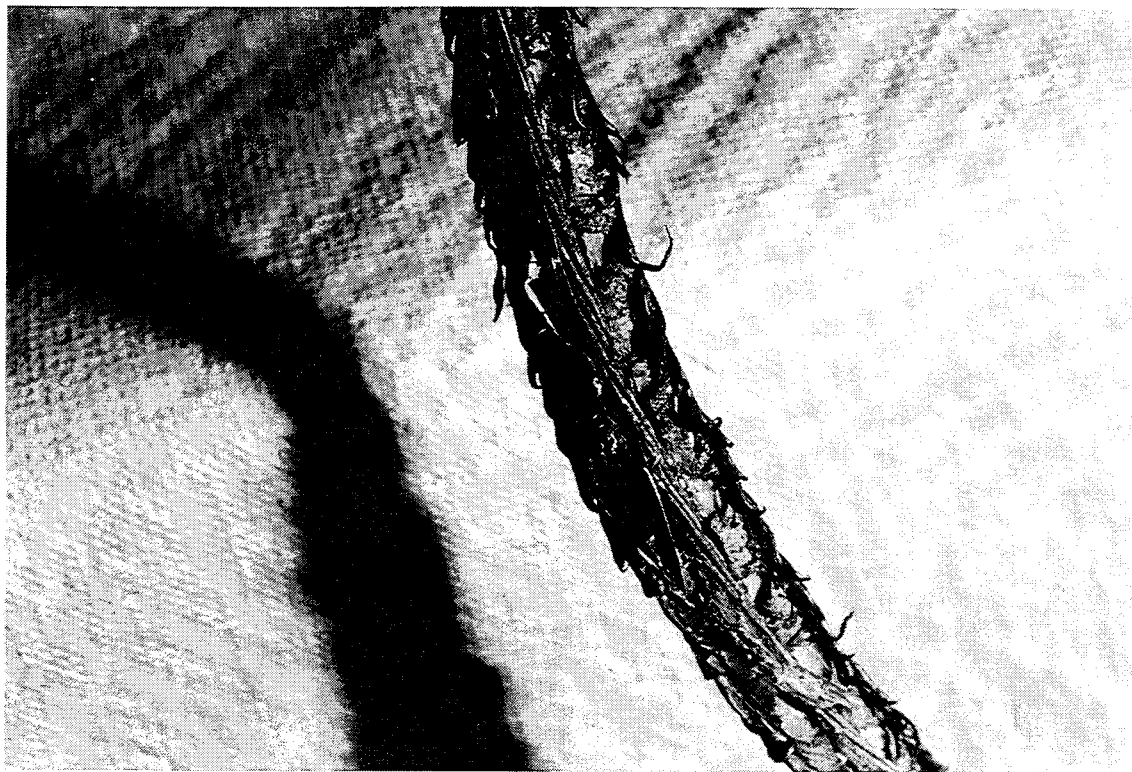
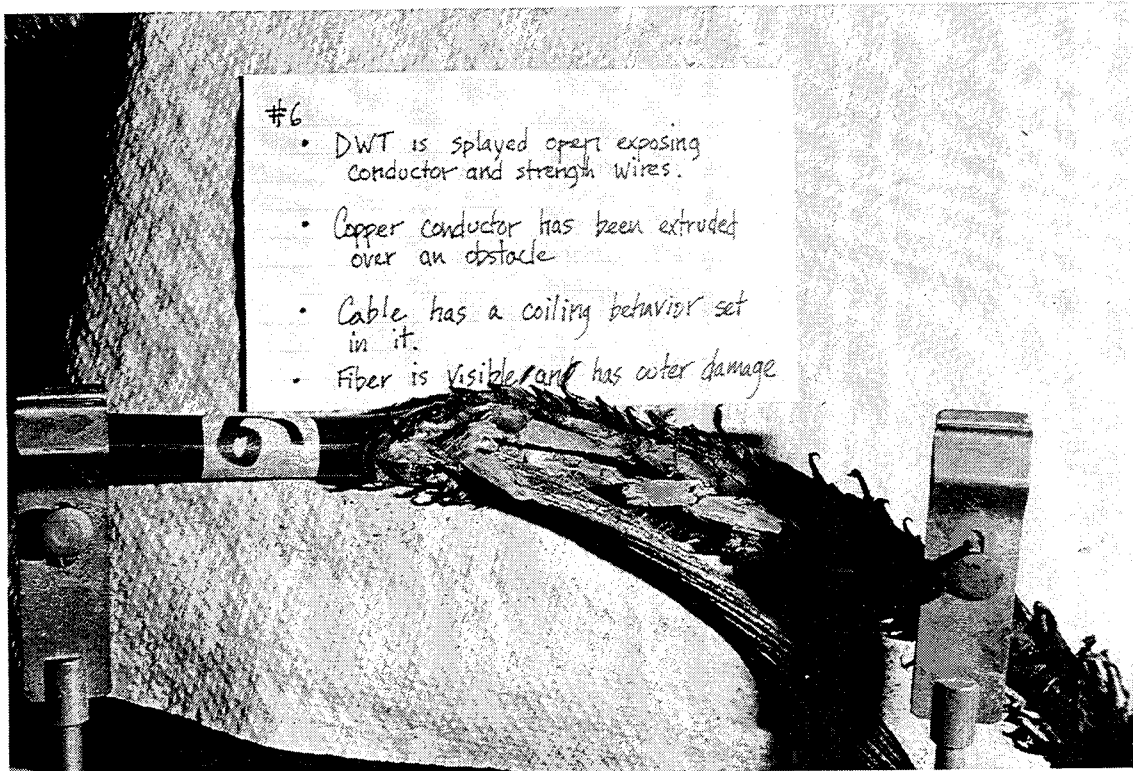
## 5.8 Fault Number 6 - FDS-D CABLE AUTOPSY WORKSHEET

Condition of Optical Fiber Sheath: The sheath is shredded exposing the buffer. Indentations from where the strength wires deformed the buffer.

Condition of Fiber: There appear to be kinks and bends in the core. Obvious catastrophic failure.

- DWT is splayed open exposing conductor and strength wires.
- Copper conductor has been extruded over an obstacle
- Cable has a coiling behavior set in it.
- Fiber is visible and has outer damage

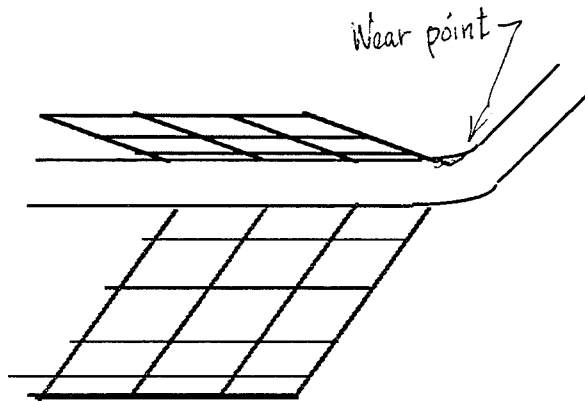
- Copper conductor is ruptured exposing strength wires.
  - Back side of fault area has been worked. Appears to have exceeded elastic limit when bent and buckled upon straightening.

- Cold flow and tearing to outer jacket.
  - Cable bent at a 30° angle where it contacted filter screen.

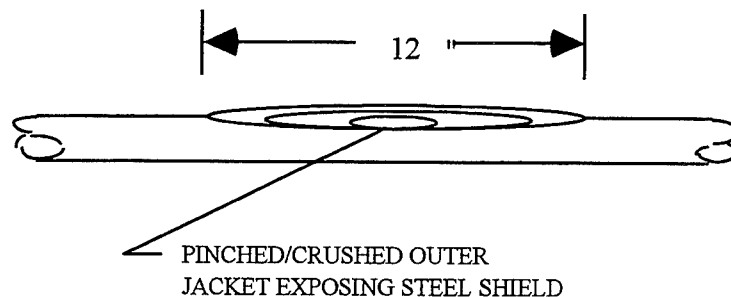
- Fault 5 - 2 meters shoreward of TR1011. Depth 80 fathoms. Fault was located near TR1011. Cable had been hit leaving a section 12" long peeled back exposing the shield. There was no obvious sign of damage past the shield. However, testing of TR1011 failed bit error rate tests. The test engineer believes the fault has a high resistance current leak to ground. There is no way of knowing if this is an optical fault because it is too close to the repeater.
